The World Bank
Global Program for Safer Schools
Samoa Mission Report

Issue | 20 January 2016

Job number 238204-01

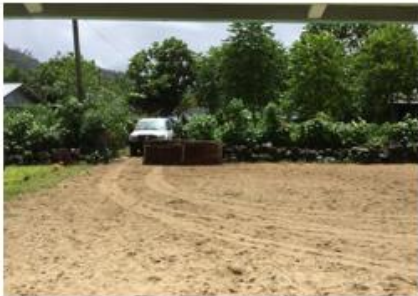
Exposure	Description	Photo
Site Location	<ul style="list-style-type: none"> Schools built on exposed sites in close proximity to the coast in tsunami zones

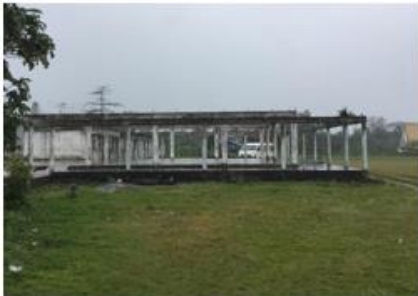
<ul style="list-style-type: none"> Schools exposed to localised flooding due to absence of site planning or drainage

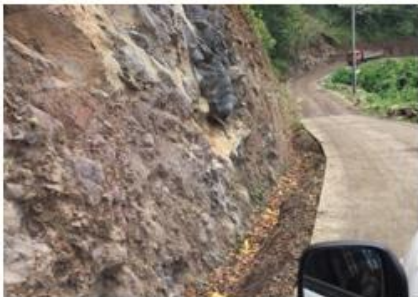
<ul style="list-style-type: none"> Schools built in areas with evacuation routes prone to landslides Schools exposed to landslides in areas with steep slopes.

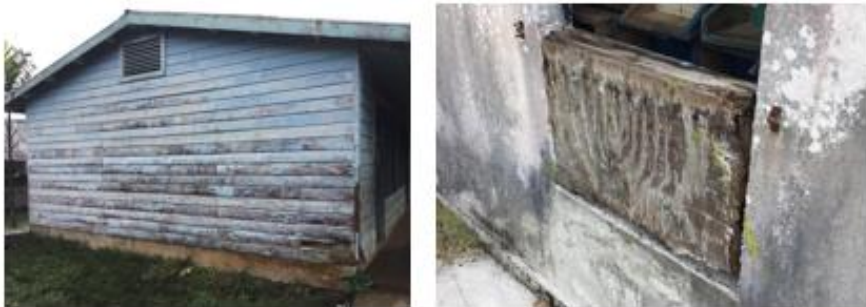
Vulnerability	Description	Photo
Age of Assets	Many schools are ~30 years old and are degrading due to lack of maintenance and the severe coastal environment

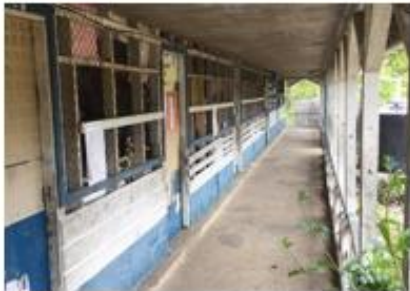
Structural Stability	Lack of stability system. Non engineered structures. Stability system in one direction only.

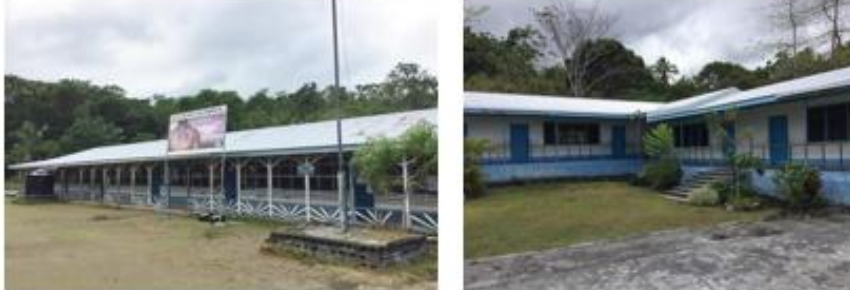
Structural form	Irregular structural form Buildings have L>4B or are "C" or "L" shaped

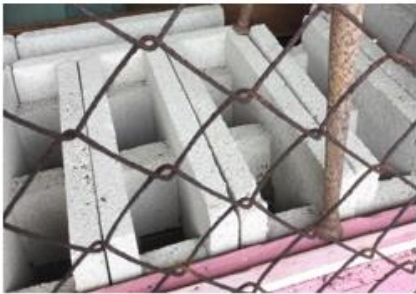
Vulnerability	Description	Photo
Poor material quality	Sea sand is often used in concrete and for making concrete blocks. Salt content in the sand leads to corrosion of steel reinforcement and concrete spalling. Whilst this was not observed regularly in Samoa, it is vital that all material used is washed.

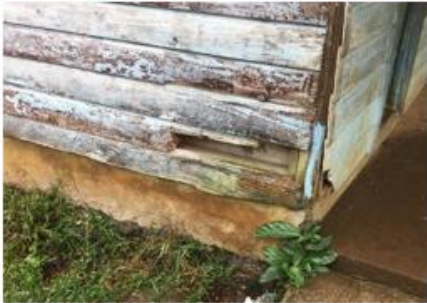
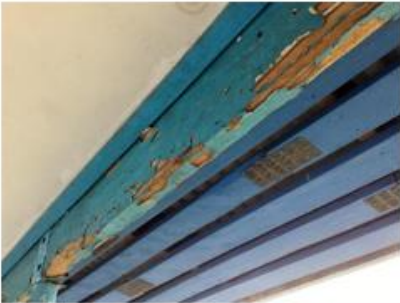
Timber degradation due to lack of maintenance and the use of untreated timber.

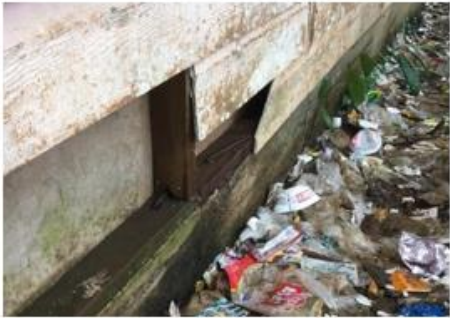
Material Selection	Materials selected must be appropriate for the conditions. Fibre cement sheet is brittle and prone to fracture. It is not recommended for use in schools where panels can easily be damaged by students. Once damaged, the underlying structure is prone to rot and weathering.

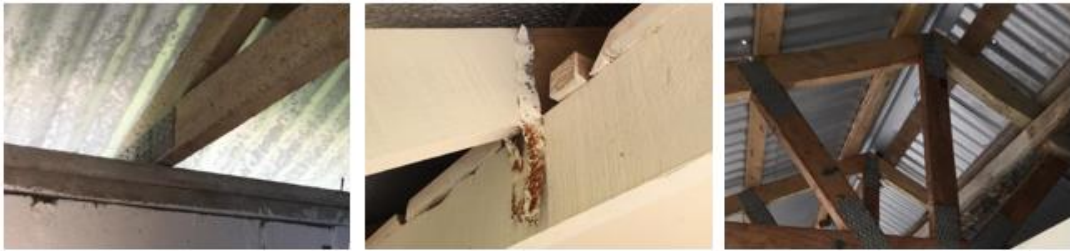
Vulnerability	Description	Photo
Roof Connections	<p>Poor connection details making schools vulnerable to high winds:</p> <ul style="list-style-type: none"> • Skew nails in lieu of strapping at roof to wall connections • Connections corrode over time in the coastal environment. • Trusses are well constructed, but purlins are not strapped to trusses.

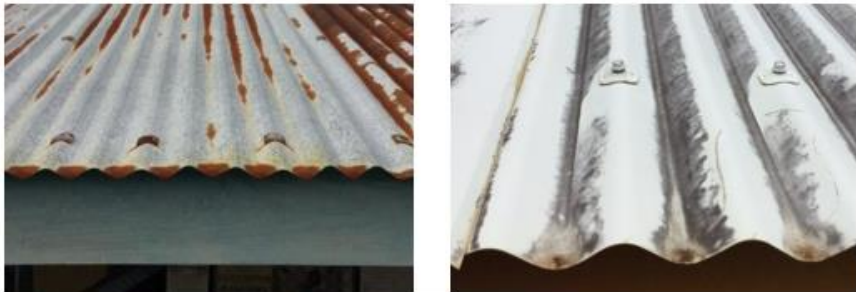
<ul style="list-style-type: none"> • Nails are used in place of screws, which are vulnerable to uplift • Poorly galvanised nails initiate corrosion in roof sheet

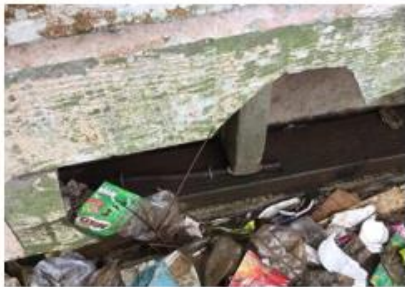
Wall Connections	<p>Poor connection details making schools vulnerable to high winds.</p> <ul style="list-style-type: none"> • Bottom plate is partially anchored, but stud not anchored to bottom plate

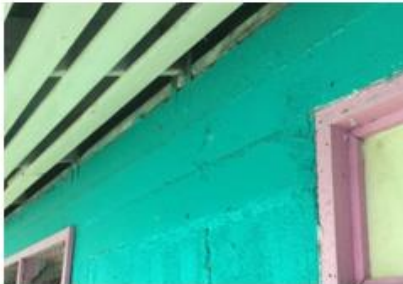
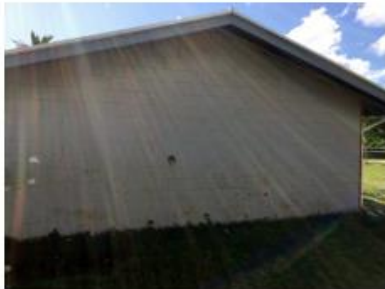
Vulnerability	Description	Photo	
Wall Detailing	<ul style="list-style-type: none"> Bond beams are required to provide horizontal connection between columns High level masonry in gable ends is an EQ hazard

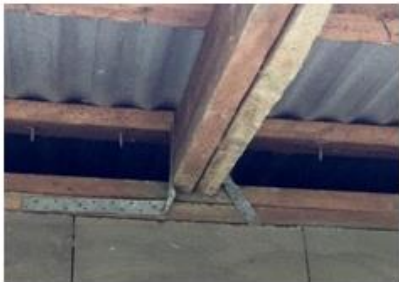
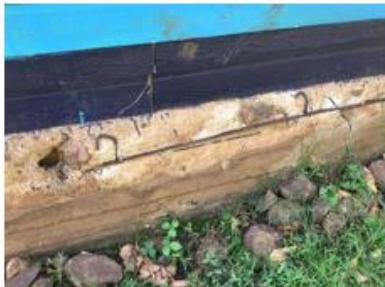
Poor workmanship	<p>A lack of site supervision allows poor quality workmanship to go unchecked.</p> <ul style="list-style-type: none"> Rafter strapping provided to top plate, but strapping methodology is incorrect and ineffective Inadequate cover to reinforcing bars in foundation

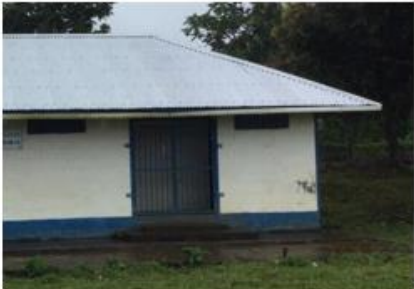
Vulnerability	Description	Photo
Appropriate Design	<p>Large eaves</p> <ul style="list-style-type: none"> Wind loads at roof edges are higher than for all other areas of a structure. The use of large eaves on structures should be avoided, or where used, careful attention should be paid to the connection of these structures to the walls.

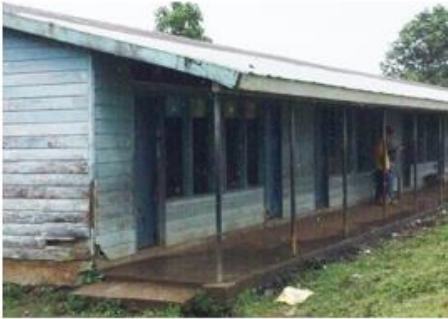
<p><u>Verandahs</u></p> <ul style="list-style-type: none"> <u>Verandahs</u> experience higher uplifts than other areas of a roof. Wherever possible, <u>verandahs</u> should be detailed as separate structures. Where they are <u>integral</u> with the main roof structure, careful attention should be paid to ensure robust connections
