Global Facility for Disaster Risk
Reduction
Global Program for Safer Schools
Indonesia Mission Report

238204-01 I R01

Issue | 6 March 2015

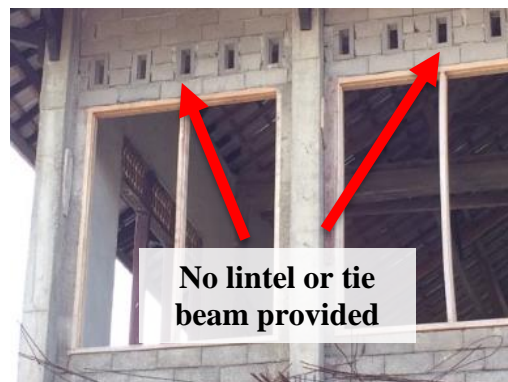
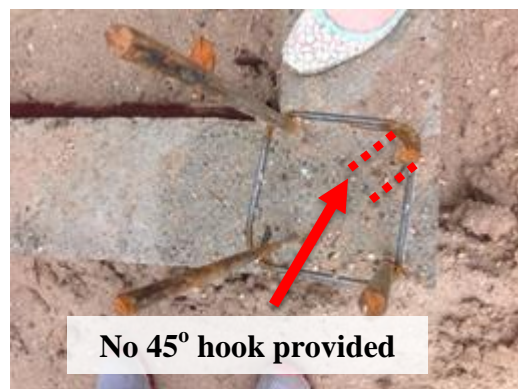
Best practice seismic design details for confined masonry construction were often found to be neglected in the schools visited, including:

- Providing lintels or reinforced tie beams over large window openings to prevent the brickwork above from loosening
- Providing seismic reinforcement details such as, 45 degree hooked leg on shear links in concrete column and beams.

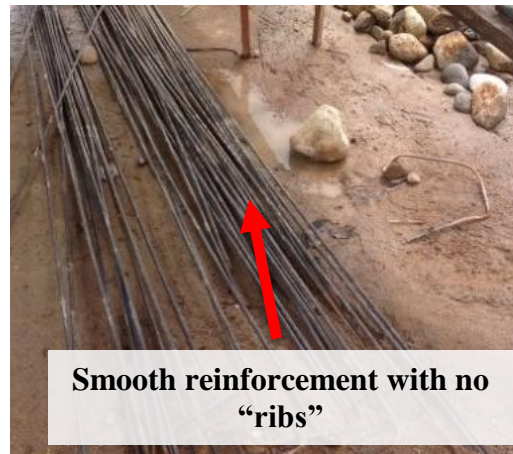
- Using deformed reinforcement. Smooth reinforcement is widely used for single/ two storey buildings. Whilst this is not international good practice for seismic design, it may be adequate for single storey buildings if engineering checks have been performed.
