The World Bank
Global Program for Safer Schools
Tonga Mission Report

Issue | 16 December 2015

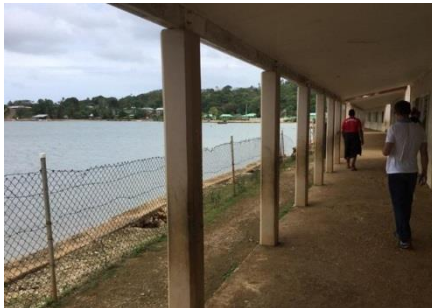
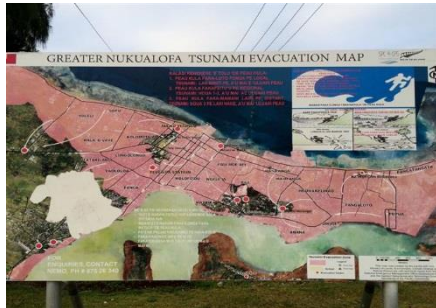
Vulnerability	Description	Preventative Action	Photo
Site Location	Schools built on exposed sites in close proximity to the coast in tsunami zones	<p>Locate schools above tsunami inundation level.</p> <p>Implement early warning systems and develop evacuation maps.</p> <p>Run evacuation drills in schools to prepare students and staff for emergency situations</p>

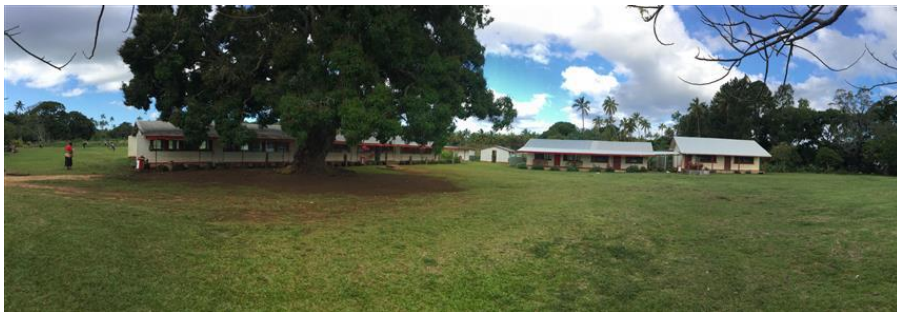
Schools exposed to localised flooding due to absence of site planning or drainage	<p>Raise school infrastructure above surrounding area.</p> <p>Implement engineering drainage solutions</p>

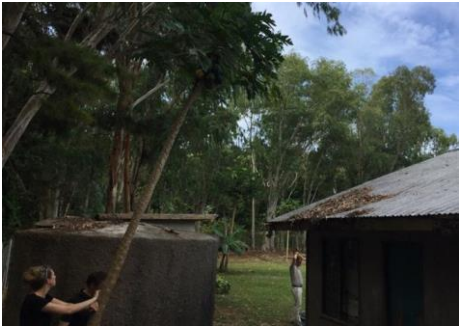
- Some school buildings were located adjacent to large trees which can fall and damage buildings during high winds and earthquakes. Furthermore there was evidence of leaf litter collecting on roofs which without regular clearing, can

lead to premature corrosion of roofs and gutters and in schools reliant on rainwater it can reduce drinking water quality.

Physical Planning	Roof impacted by falling debris and corroding prematurely. Rainwater collection compromised by leaf litter	Locate structures away from large trees or unsafe structures which can fall on structures during a cyclone or earthquake. Provide regular maintenance to clear gutters and roofs of debris

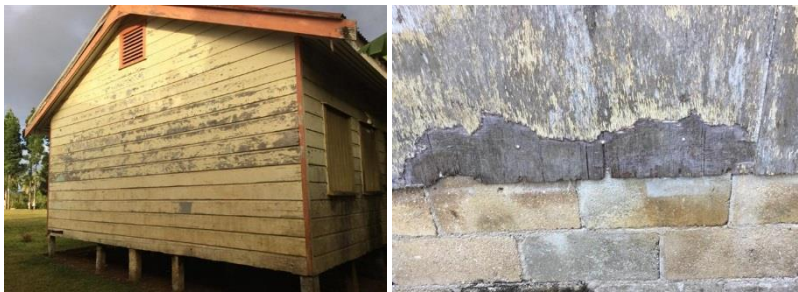
Vulnerability	Description	Preventative Action	Photo
Age of Assets	Many schools are ~30 years old and are degrading due to lack of maintenance and the severe coastal environment	Maintain structures regularly to prevent degradation of materials.

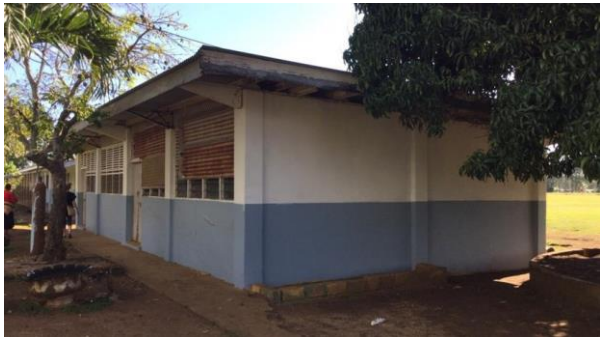
Structural Stability	Lack of stability systems Non engineered structures	All school buildings should be engineered. Development of a standard set of engineered drawings will enable MOET to develop a consistent approach to school construction.

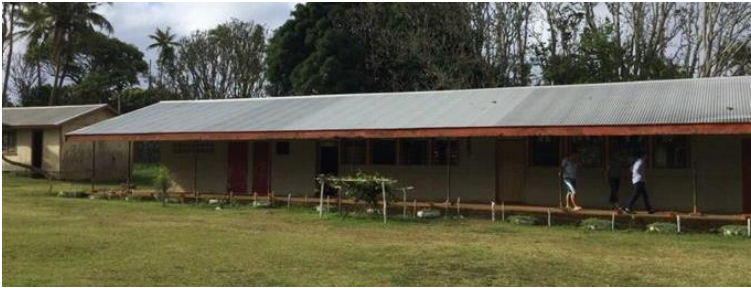
Structural form	Irregular structural form Buildings have $L > 4B$	Buildings should not be wider than 4 times their width. Buildings longer than this should be broken up into two separate structures.

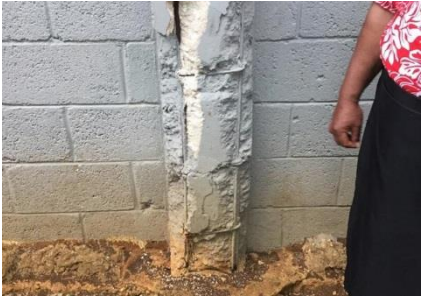
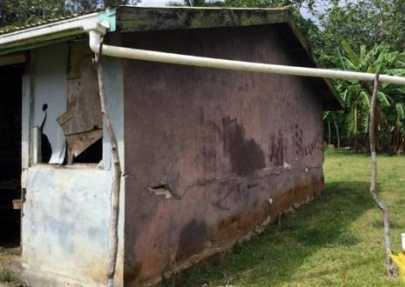
Poor material quality	Sea sand is often used in concrete and for making concrete block, where the salt content leads to corrosion of steel reinforcement and concrete spalling.	Sea sand be stockpiled for six months and exposed to rainfall and/or washed with fresh water before use, to remove the salt.

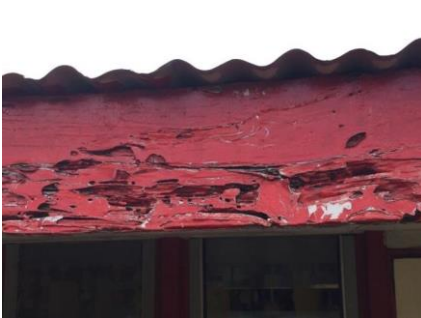
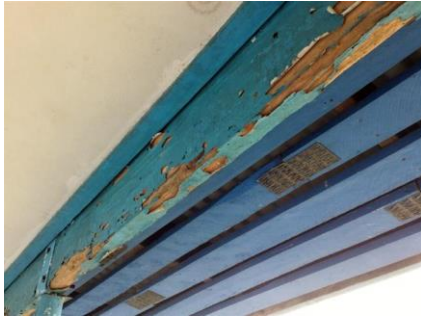
Timber degradation due to lack of maintenance or the use of untreated timber, leading to rot, termite and borer attack. Local timber used which is not strength or durability rated.	Preservative treated timber or hardwoods resistant to insect attack should be used. Knowledge of timber species is required if local timbers are to be used to ensure they are durable. A conservative approach to strength grading is required.

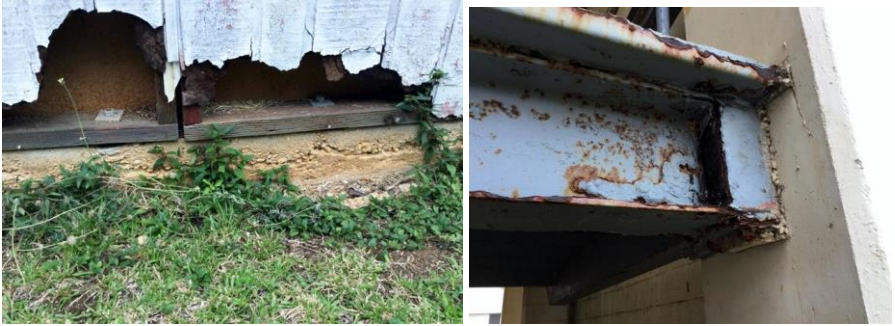
Material Selection	<p>Masonite used for external cladding is not durable</p> <p>Heavy steel beams require maintenance, and is a system which is not understood locally</p>	<p>Materials selected must be appropriate for the conditions, readily available and be in widespread use.</p>

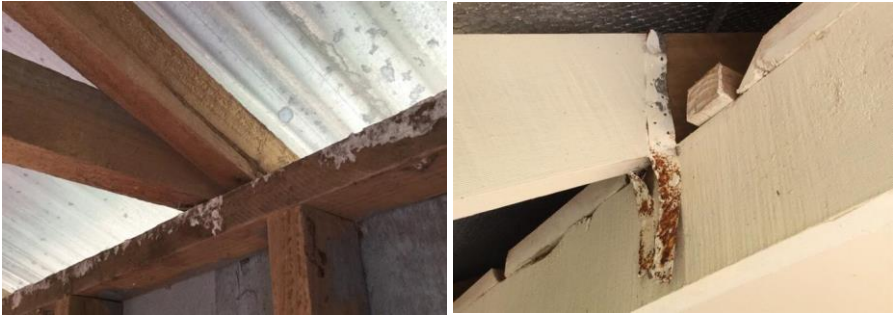
Roof Connections	<p>Poor connection details making schools vulnerable to high winds: Skew nails in lieu of strapping at roof to wall connections</p> <p>Connections corrode over time in the coastal environment.</p>	<p>Provide robust, engineered connections that are durable. Consider using large diameter galvanised bolts or stainless steel strapping. Provide ongoing maintenance for connections</p>

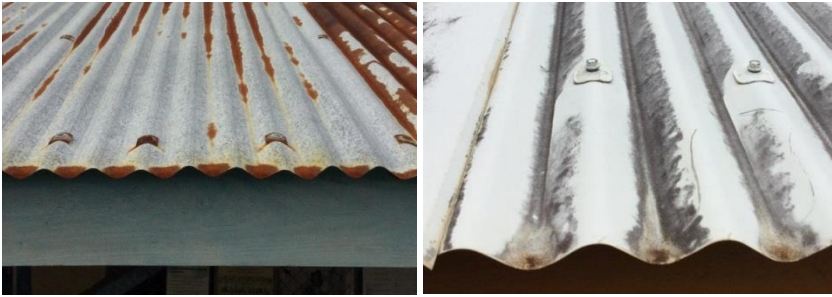
<p>Nails are used in place of screws, which are vulnerable to uplift</p> <p>Poorly galvanised nails initiate corrosion in roof sheet</p>	<p>Use roof screw with cyclone washers for all roof sheet connections. Sheets should be screwed in accordance with manufacturers specification</p>

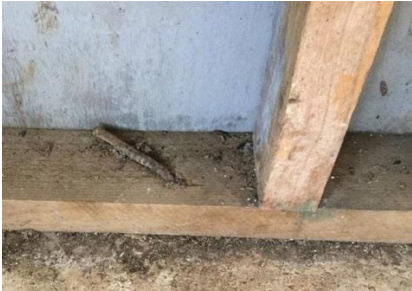
Wall Connections	<p>Poor connection details making schools vulnerable to high winds.</p> <p>Bottom plate is partially anchored, but stud not anchored to bottom plate</p>	<p>All connections should be engineered.</p> <p>Suitably qualified supervision is required on all building sites to ensure that buildings are constructed in accordance with the design intent.</p>

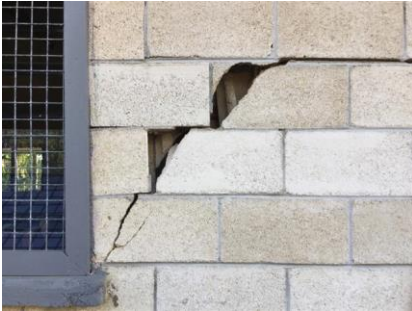
Unreinforced Masonry	<p>URM is not suited to seismic zones due to its brittle failure mode</p>	<p>Ensure that all masonry is reinforced</p>

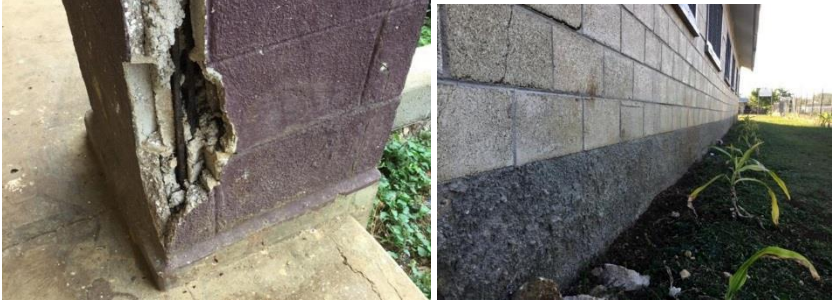
Poor Wall Detailing	<p>Poor detailing reduces structures strength.</p> <p>High level masonry in gable ends is an EQ hazard.</p>	<p>Reinforcing bars should tie between walls and columns. Bond beams are required to provide horizontal connection between columns.</p> <p>Masonry in gable ends should be suitable reinforced or avoided</p>

Poor workmanship	<p>A lack of site supervision allows poor quality workmanship to go unchecked. Reinforced masonry column not core filled</p> <p>Foundations built on poor soil have subsided.</p>	<p>Suitably qualified supervision is required on all building sites to ensure that buildings are constructed in accordance with the design intent.</p>

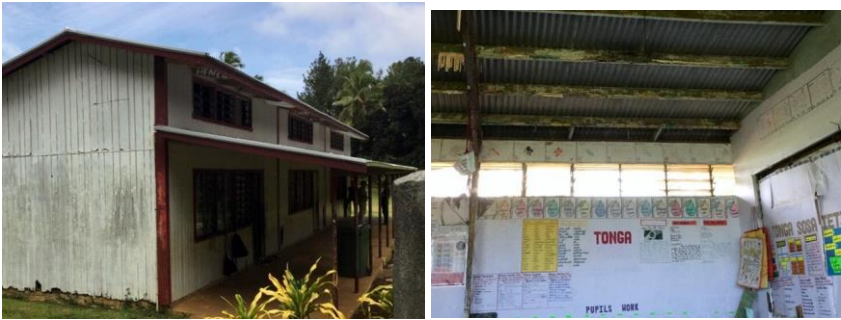
Appropriate Design	<p>High level windows are not accessible to close by staff and students.</p> <p>Damage to building contents during high wind events.</p>	<p>All designs should take into account the relevant local hazards and likely resources and capacity of building users.</p> <p>Buildings should be as simple as possible.</p>
