The World Bank  
**Global Program for Safer Schools**  
Vanuatu Mission Report

Issue | 20 December 2015

Job number 238204-00

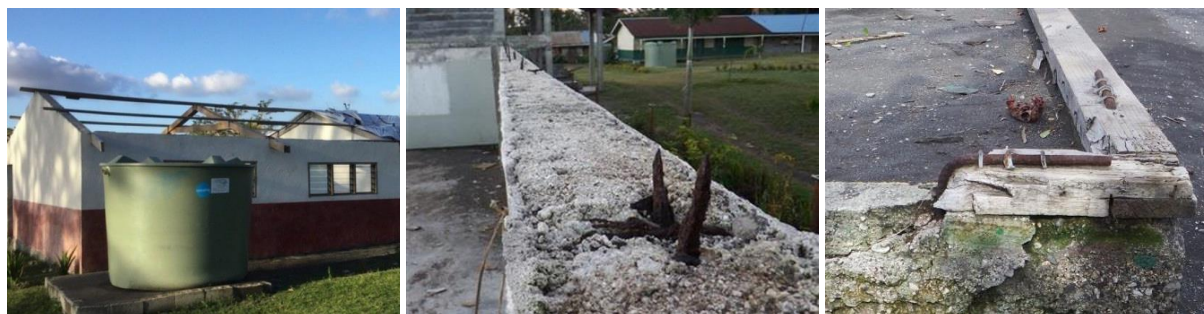
Figure 2: Loss of roof sheet from the use of roofing nails (not screws) and a large purlin spacing (L). Loss of roof from corroded rafter to wall connections (M). Complete loss of building as the wall bottom plate is anchored to the foundation, but the walls are not anchored to the bottom plate (R)

Typically the effectiveness of connections was limited by poor detailing practices, degradation of the connections due to corrosion and the limited availability of materials or insufficient finances to purchase materials, suitable for creating strong, durable connections. In the absence of design documentation, it is unclear whether the poor quality of connections was due to inadequate design, an absence of design or a failure of builders to follow the design.

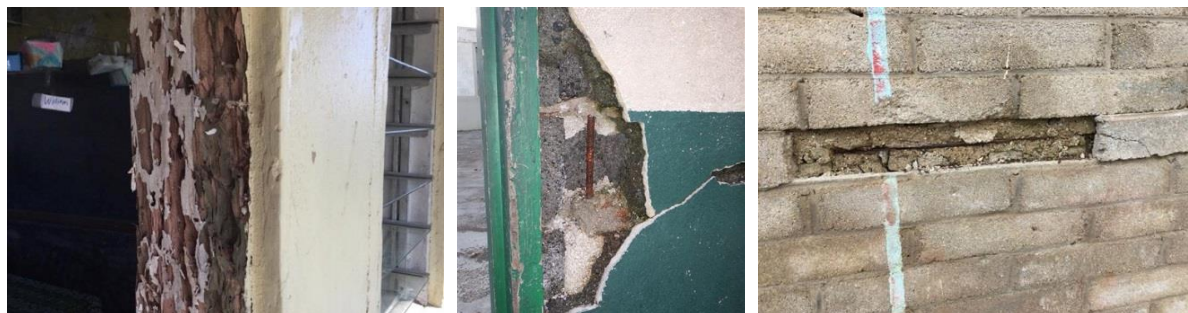
Beach sand and crushed coral was the predominant material used for the production of concrete, which in some cases was observed to be causing corrosion of the reinforcement in concrete elements. Without adequate washing with fresh water, the salt content in beach sand leads to the rusting of steel, causing the concrete to spall, further exposing the steel to the external environment and decreasing its structural capacity. At a number of schools interviewees were asked about washing beach sand and there did not appear to be an understanding of the need to wash it before use. Washing sand can be a challenge due to the reliance on limited amounts of rainwater or the need to pre-plan works by storing sand in the weather for around six months for the salt to be washed out.

Figure 3: Insect attack to untreated timber (L). Incomplete core filling of concrete blocks (M). Wall reinforcement corrosion likely resulting from concrete made with unwashed sea sand (R)

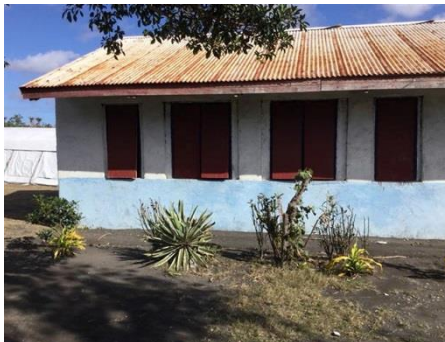
| Vulnerability | Description | Preventative Action | Photo |
|---|--|--|--|
| <b>Age of Assets</b> | Many schools are ~30 years old and are degrading due to lack of maintenance and the severe coastal environment | Maintain structures regularly to prevent degradation of materials. | |

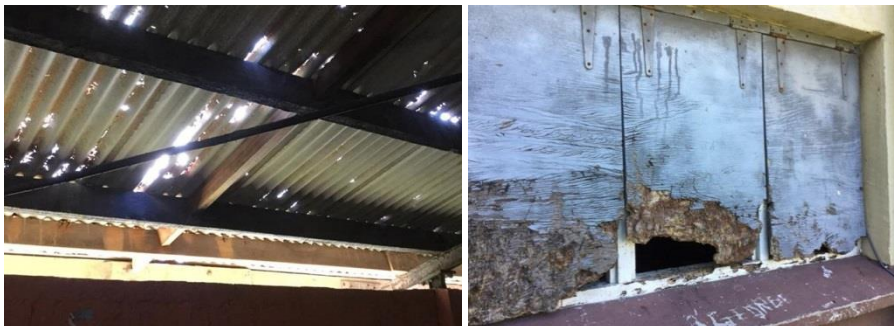
| Vulnerability | Description | Preventative Action | Photo |
|---|--|--|--|
| <b>Maintenance of Assets</b> | Corrosion of roof sheeting<br>Degradation of window shutters | Provide preventative maintenance to roof sheet by painting regularly. Replace sheet once degraded, before supporting structure is damaged.<br><br>Paint timber to prevent damage. Select durable materials (external ply), or clad with tin sheet. | |

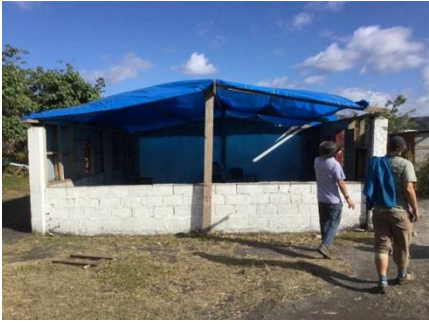
| <b>Structural Stability</b> | Lack of stability system.<br>Non-engineered structures. | All school buildings should be engineered. Development of a standard set of drawings will enable MoET to freely distribute engineered designs to communities. | |

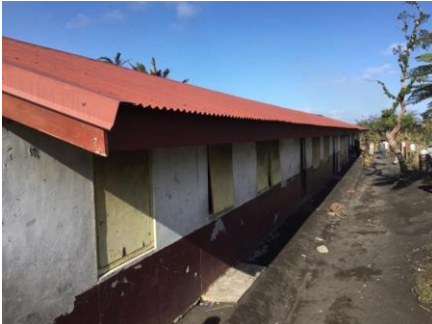
| <b>Structural form</b> | Irregular structural form.<br>Buildings have $L > 4B$ , making them more susceptible to earthquake loading. | Buildings should not be wider than 4 times their width.<br>Buildings longer than this should be broken up into two separate structures. | |

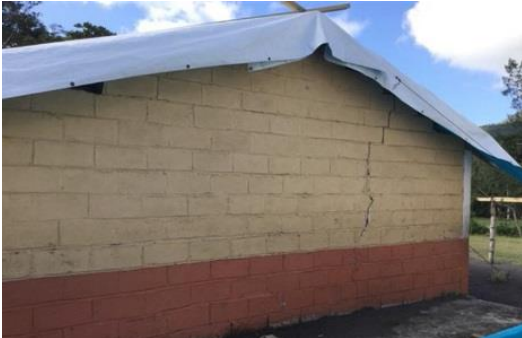
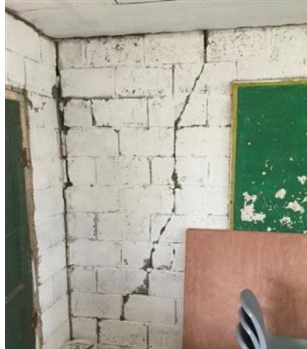
| <b>Unreinforced Masonry</b> | URM is not suited to seismic zones due to its brittle failure mode. | All masonry structures should be reinforced vertically and horizontally, and core filled at all reinforcement locations.<br>Corners and intersections of all walls should be linked with reinforcement. | |

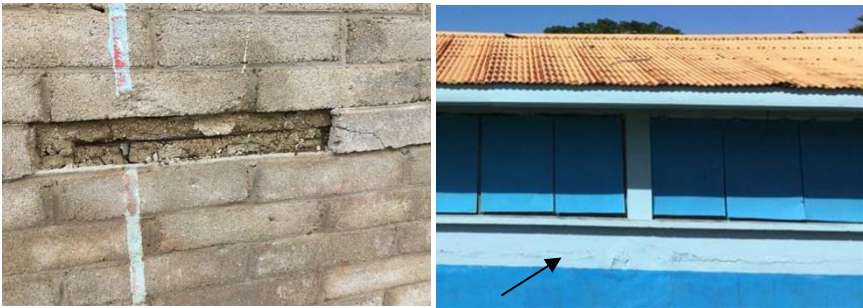
| <b>Material quality and selection</b> | Sea sand is often used in concrete and for making concrete block, where the salt content leads to corrosion of steel reinforcement and concrete spalling | Sea sand be stockpiled for six months and exposed to rainfall and/or washed with fresh water before use, to remove the salt. | |

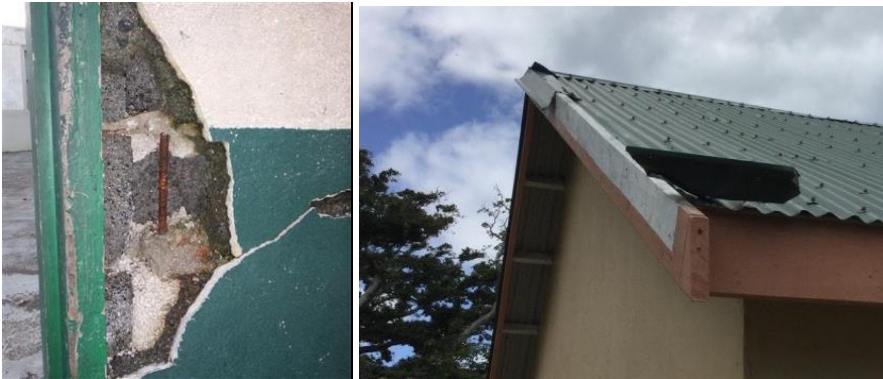
| <b>Workmanship</b> | <p>A lack of site supervision allows poor quality workmanship to go unchecked.</p> <p>Reinforced masonry column not core filled</p> <p>Lack of screws at flashing ends</p> | Site supervision by suitably qualified trades should be provided for all school buildings, to manage quality on site and ensure that buildings are constructed in accordance with the design intent. | |

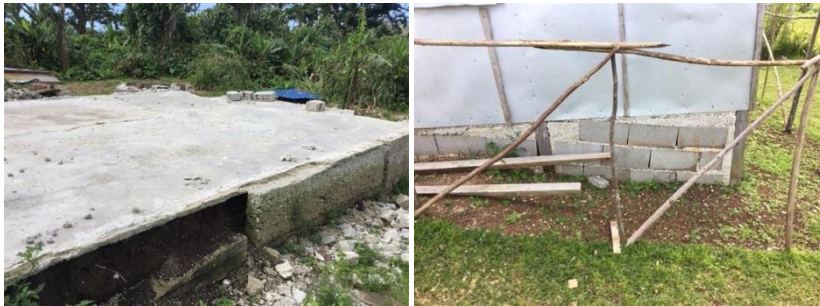
| <b>Foundation Design and Construction</b> | Lack of adequate foundations | All school buildings should be engineered. Development of a standard set of drawings will enable MoET to freely distribute engineered designs to communities. | |

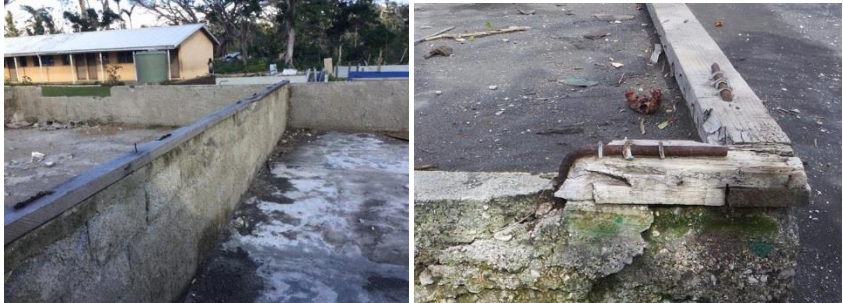
| <b>Wall Design and Construction</b> | <p>Poor connection details making schools vulnerable to high winds.</p> <p>Bottom plate is partially anchored, but stud not anchored to bottom plate</p> | Bottom plates on timber frame walls must be suitably anchored to skirt walls and/or slabs and walls must be strapped to bottom plates. | |

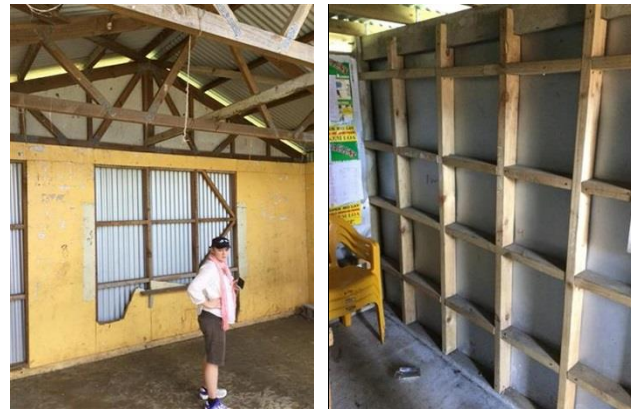
| | Inadequate bracing in timber frame walls | Timber walls should be suitably braced with galvanised steel strapping or wall sheeting. | |

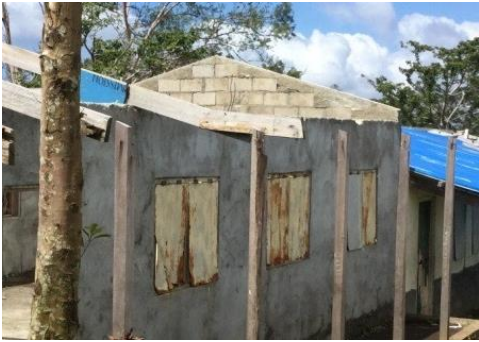
| <b>Wall Design and Construction</b> | High level masonry in gable ends is susceptible to earthquake loads. | Eliminate high level masonry where possible, and substitute with lightweight cladding. Alternately, provide sloping bond beam at top of gable walls. | |

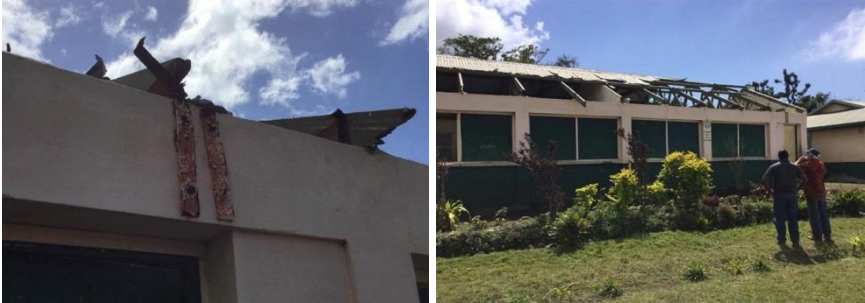
| <b>Roof Design and Construction</b> | Large Verandahs or eaves are susceptible to wind uplift. | Provide verandahs as a separate attached element to protect main roof in the event of roof failure. Alternately, engineer connections for full uplift. | |

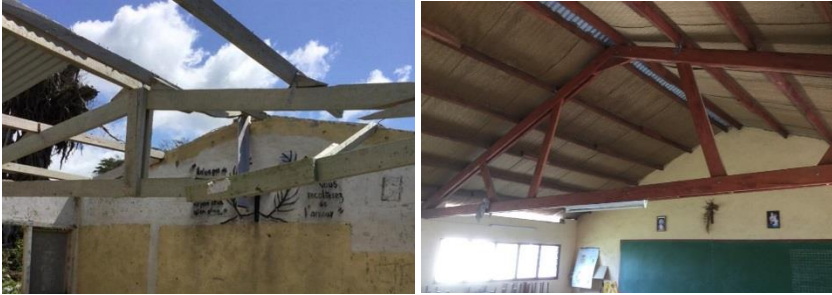
| | Trusses are not designed or constructed correctly. | Build trusses to an engineered design. Provide diagonal members that node out. | |

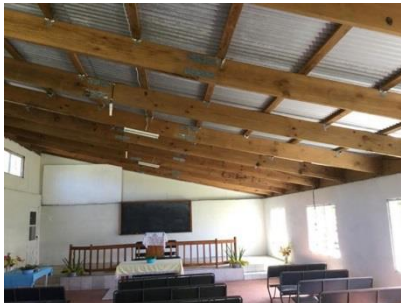
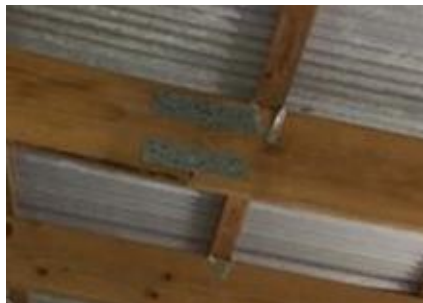
| <b>Roof Design and Construction</b> | Beams are poorly connected at mid span. | Use continuous members wherever possible, or provide suitably robust splice at joints. | |

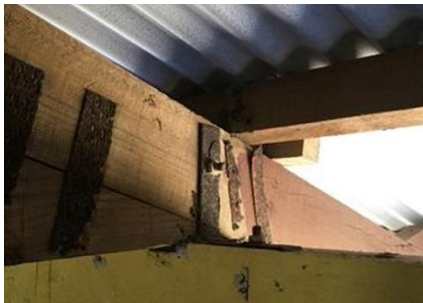
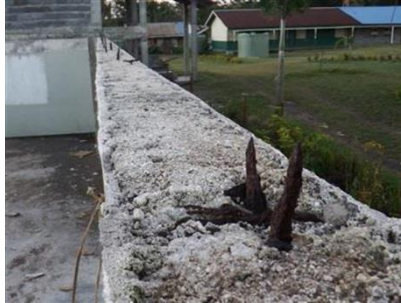
| | Connections are susceptible to corrosion from proximity to the ocean and emissions from the volcano. | <p>Use galvanised, large diameter bolts and 5mm min thick strip plate where possible for connections.</p> <p>Use stainless steel strapping.</p> <p>Maintain connections by regular inspection and re-application of paint.</p> | |

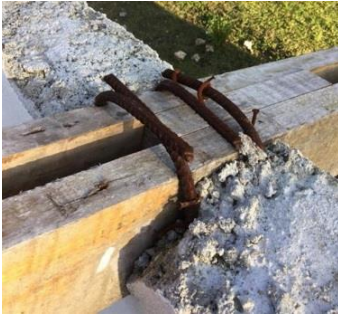
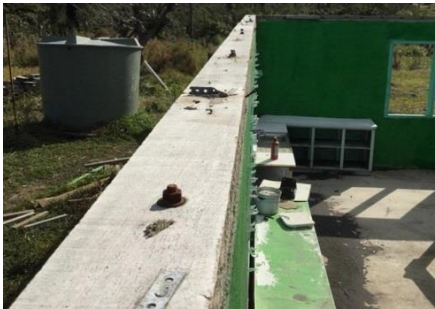
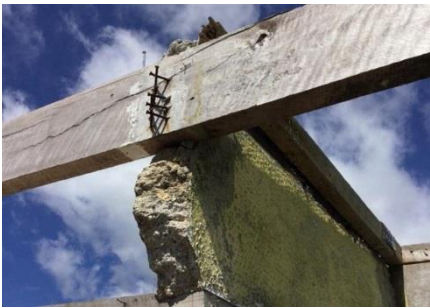
| <b>Roof Design and Construction</b> | <p>a) Poor wall to roof structure connections are vulnerable to wind uplift. Reinforcement from the column below is looped over truss.</p> <p>b) Top plate anchored to wall, but inadequate connection of roof structure to top plate.</p> <p>c) Nails embedded into insitu concrete wall susceptible to shearing concrete under uplift</p> | <p>Provide robust anchorage of reinforcing bars to roof structure or use U bars cast into ring beam.</p> <p>Provide adequate strapping from truss to wall plate.</p> <p>Provide alternate fixing detail.</p> | <p>a) </p> <p>b) </p> <p>c) </p> |

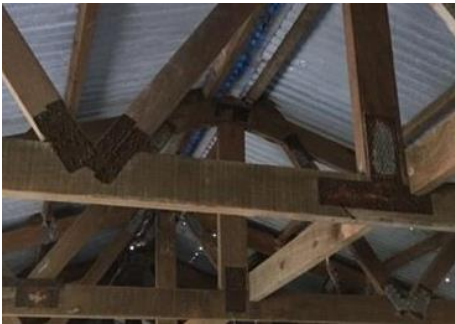
| | <p>Corrosion of gang nails.</p> | <p>Large diameter galvanised bolts should be used rather than gang nails for increased durability. If gang nails are used, they should be galvanised and painted regularly to inhibit corrosion</p> | |

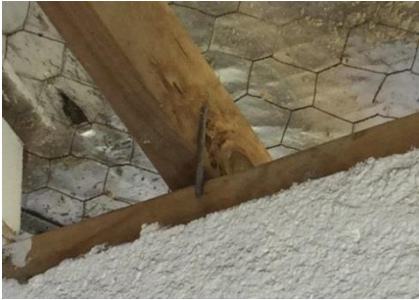
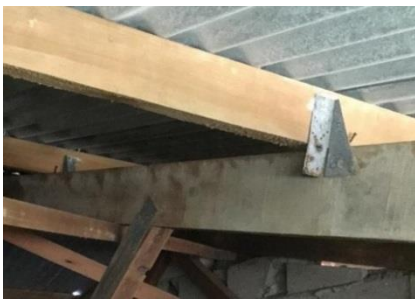
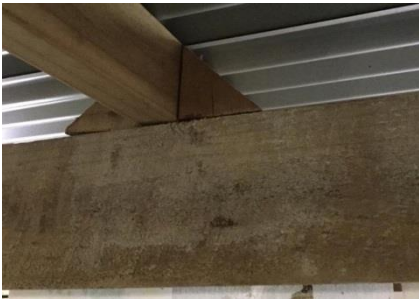
| <b>Roof Sheet Design and Construction</b> | <p>a) Unsuitable 'Z nail' connection from rafter to wall plate.</p> <p>b) Unsuitable 'triple grip' connections from purlins to rafters.</p> <p>c) Unsuitable timber blocks used with skew nails to connect purlins to rafters.</p> | <p>Galvanised iron or stainless steel strapping should be used for all purlin to rafter connections, and for rafter to top plate connections where (spacing of rafters/trusses is small <math>\leq 1.2\text{m}</math>).</p> <p>Straps should loop over top member (rafter or purlin), with nails anchored in shear on both sides of bottom member (rafter or top plate).</p> | <p>a) </p> <p>b) </p> <p>c) </p> |

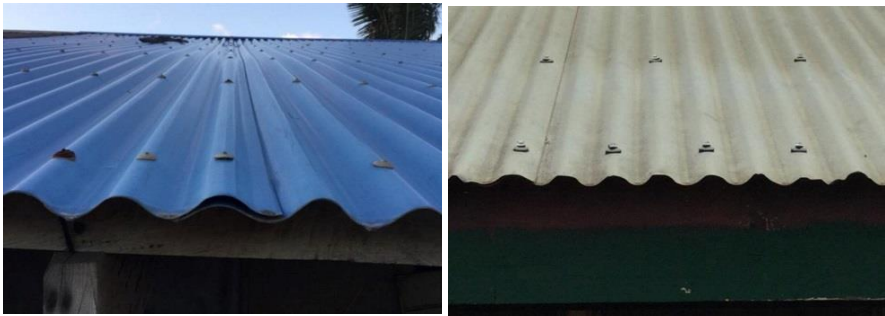
| | <p>Nails are used in place of screws, which are vulnerable to uplift.</p> <p>Roof sheets are incorrectly lapped, leaving them vulnerable to uplift.</p> <p>Screws used without cyclone washers.</p> | <p>Use roof screw with cyclone washers for all roof sheet connections. Sheets should be screwed in accordance with manufacturers specification.</p> | |
