Global Facility for Disaster Risk
Reduction
Global Program for Safer Schools
Mongolia Mission Report

Issue | February 6, 2015

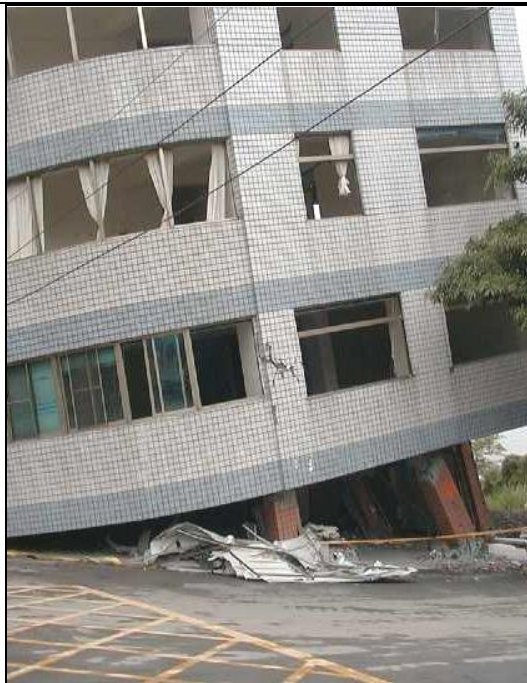
Collapse of ground level caused by Vertical irregularity

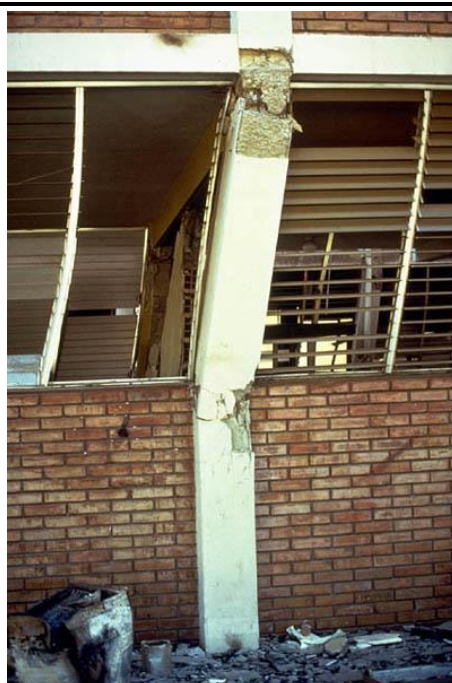
Damage to primary structure caused by interaction between non-structural masonry and RC frame

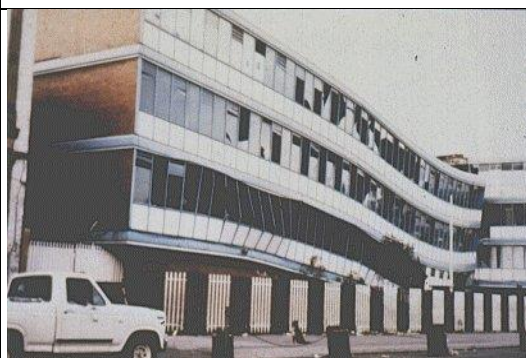
Torsional damage caused by plan irregularity, specifically $I > 4b$

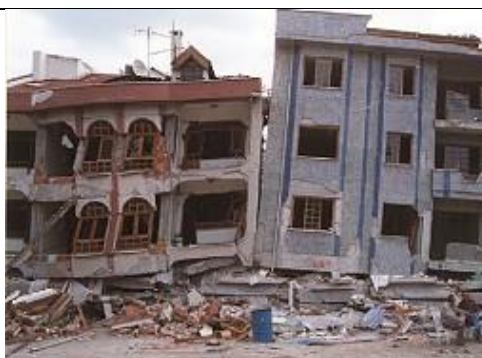
Damage resulting from pounding

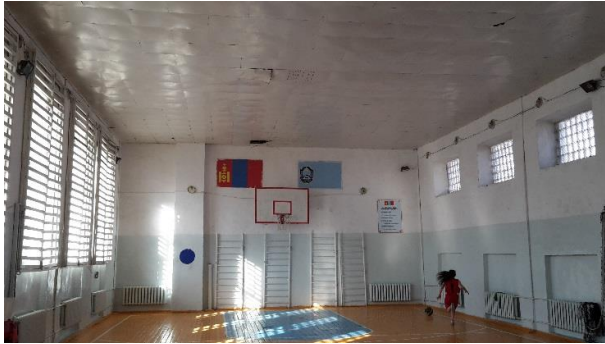
Figure G1.1 - Double height gym - with large openings with loosely fastened timber shutters on one side. Opening size reduced by infilling windows on other side after construction resulting in no bond between old and new masonry.

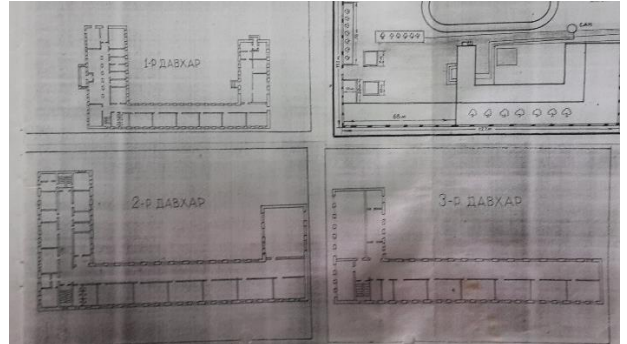
Figure G1.2 - Internal walls - are continuous for classroom block along the bottom of the page but vary between floors for left hand block, with several discontinuing above entrance hall.

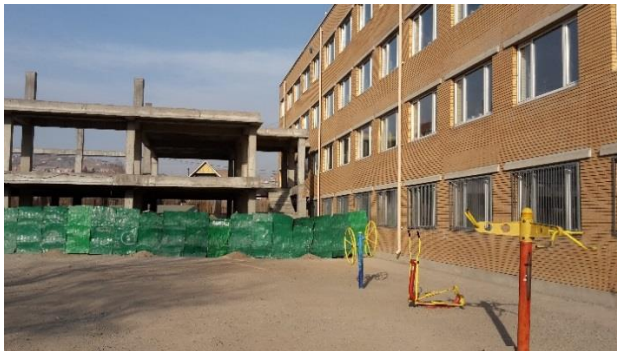
Figure G1.3 - New building - built immediately adjoining to existing with seemingly no consideration to seismic movement joints.

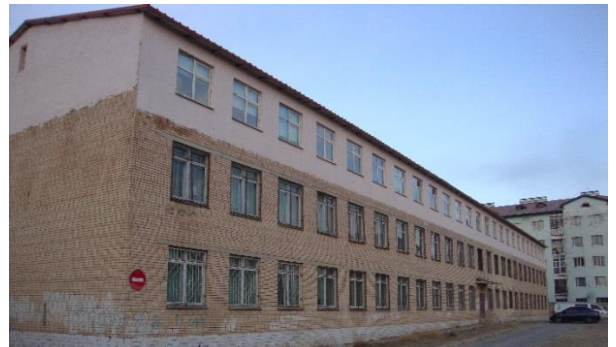
Figure G1.4 - Additional story - added to Model Soviet School design.

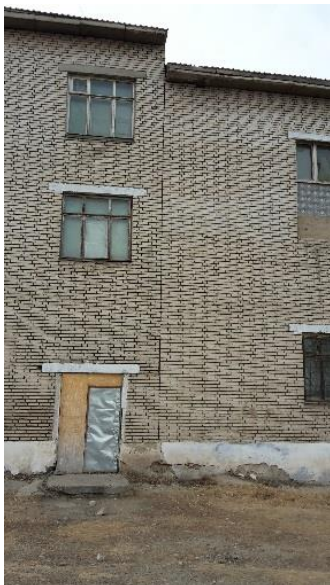
Figure G1.4 - Movement joints - Soviet model schools typically consist of C or E shaped plans with non-seismic expansion joints dividing them into rectangular segments.

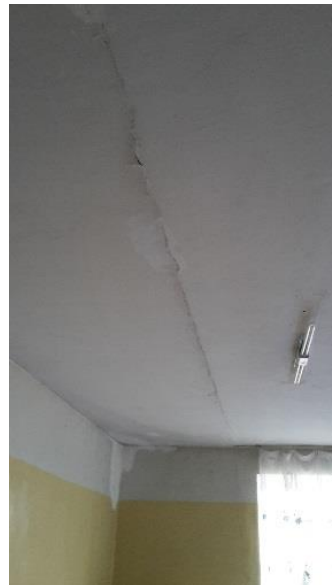
Figure G1.5 - Precast plank - joint made clearly visible by damage caused to plaster via moisture ingress

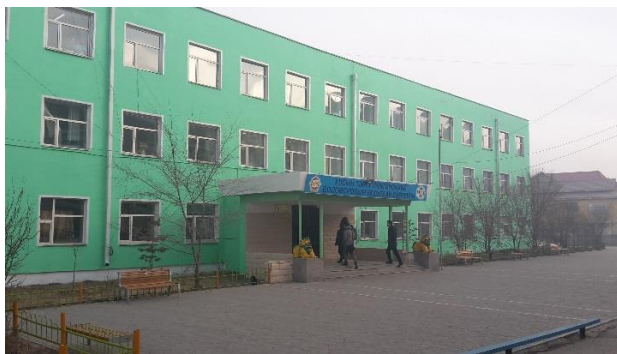
Figure G1.7 - Heavy weight covered entrance way – are potentially vulnerable in an earthquake.

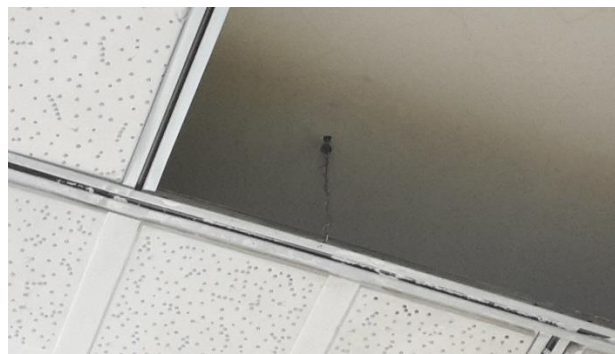
Figure G1.8 - Suspended ceiling panels - loosely connected back to building fabric are also potentially vulnerable in an earthquake.

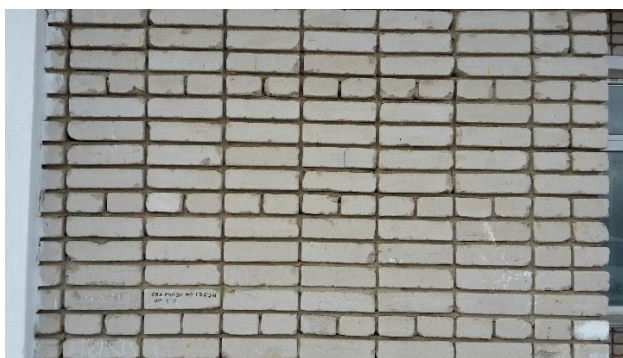
Figure G2.1 - Masonry bonding - Poorly bonded outer masonry course. Vertical mortar joints align over 3 courses.

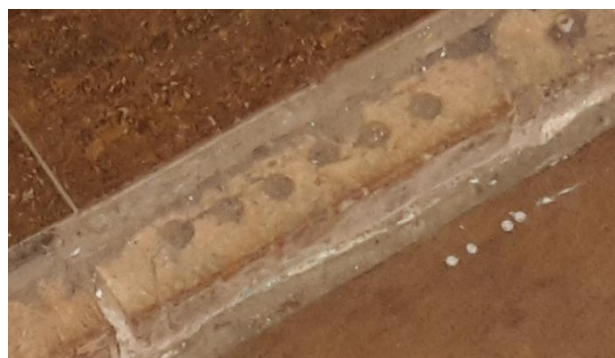
Figure G2.2 - Brick types - Yellow bricks with vertical holes susceptible to end damage

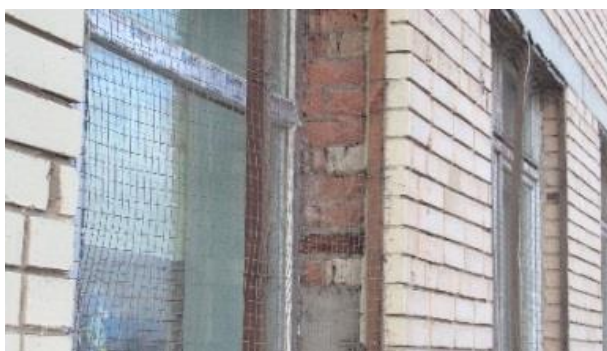
Figure G2.3 - Brick types and bonding - Damaged brickwork around window showing red brick masonry behind external yellow brick leaf. Yellow brick leaf is bonded back into red brick masonry every 4th course.

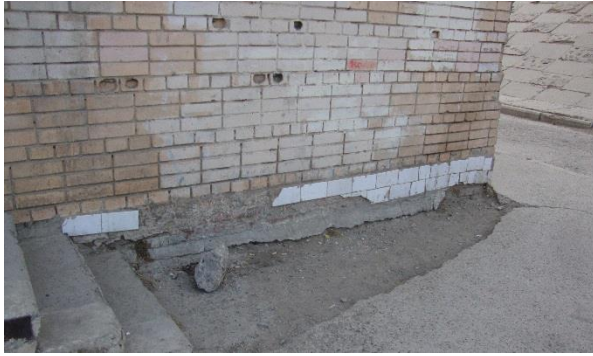
Figure G3.1 - Masonry deterioration - damaged bricks and base of wall undermined.

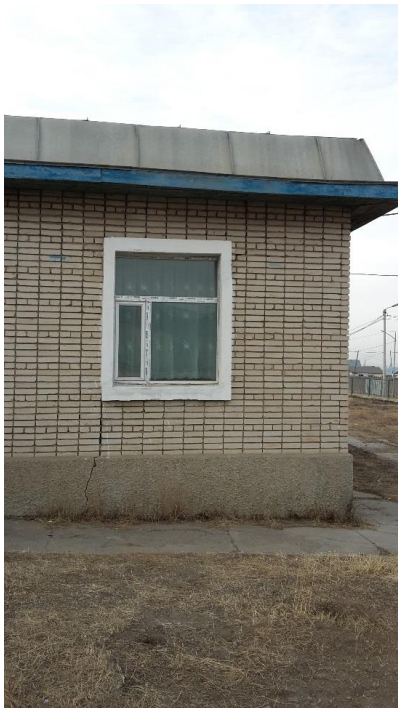
Figure G3.2 - Cracking in walls - consistent with foundation movement. Possibly due to frost heave and or subsequent settlement.

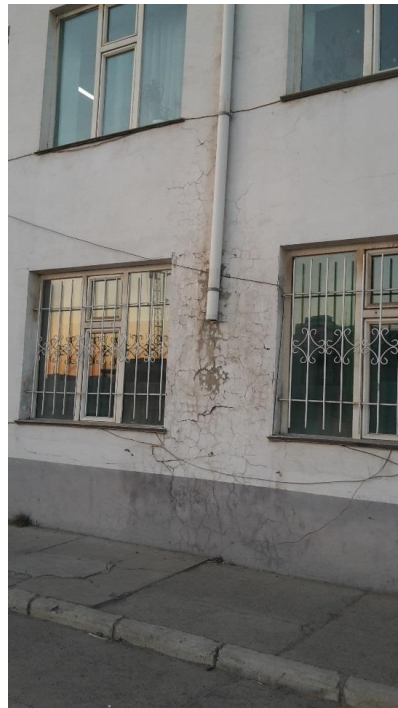
Figure G3.3 - External water damage - to wall (and foundations) caused by roof gutter terminating several meters above ground. No site drainage.

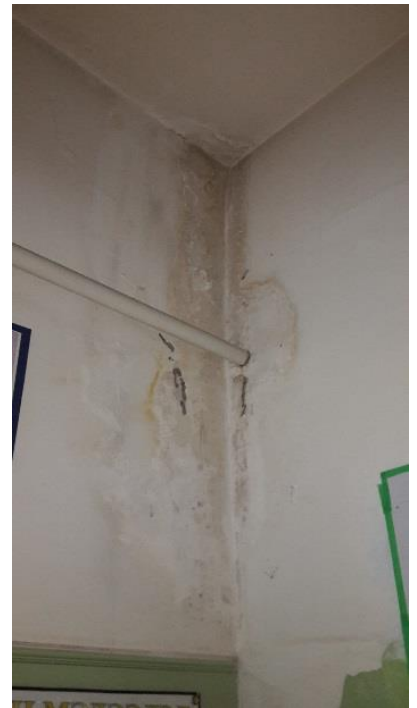
Figure G3.4 - Internal water damage - associated with leaking roofs and or burst water pipes.
