Global Facility for Disaster Risk
Reduction
Global Program for Safer Schools
Indonesia Mission Report

238204-01 I R01

Issue | 6 March 2015

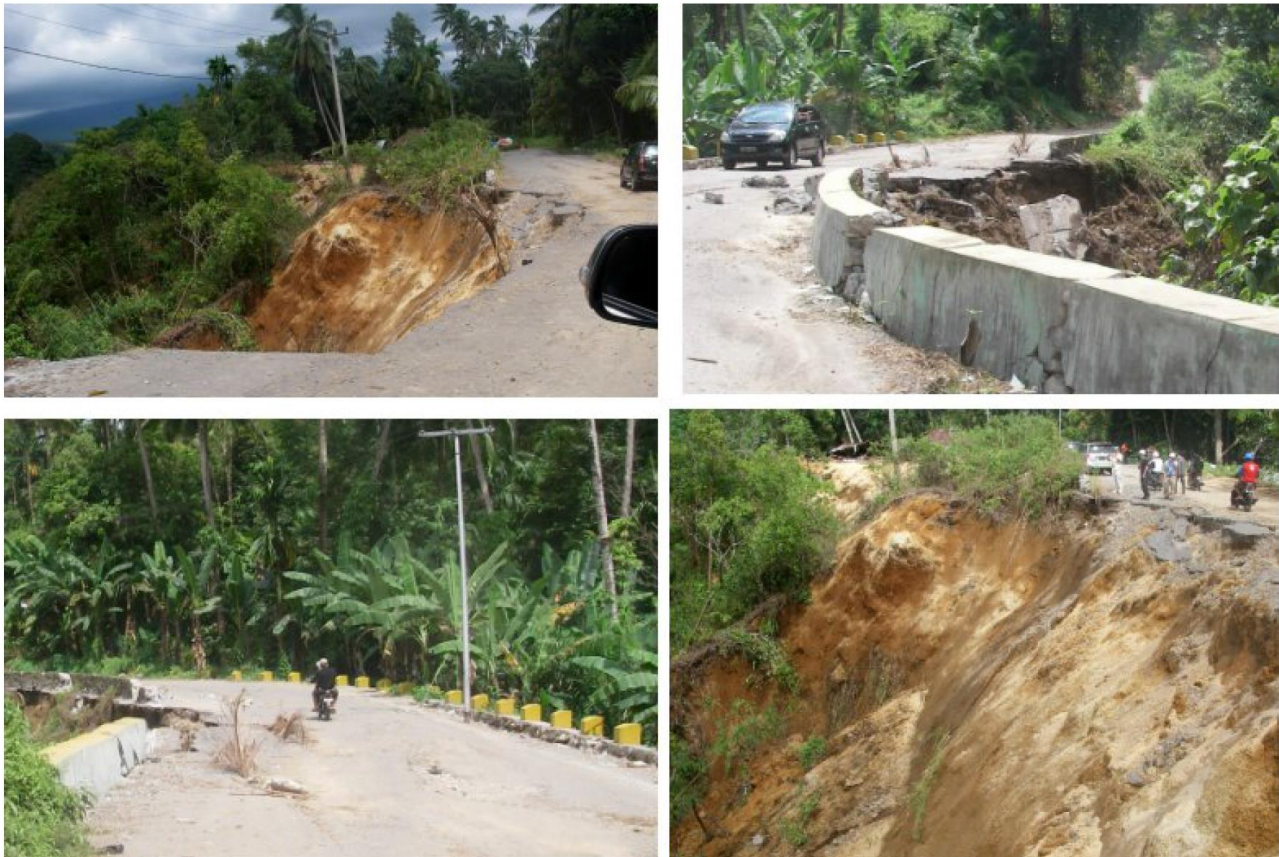
In the 2009 earthquake, slope failures caused extensive damage of roads in the mountainous region east of Padang city. Slope failures in the loosely packed volcanic ash deposits were initiated by ground shaking associated with the earthquake, and further enhanced by the high water content of the deposits, their lack of cohesive force, and the dip of bedding towards the slope direction (Aydan, 2009). Figure 7 shows damage to roads in Padang Alai. Some damage also occurred to roadways resulting from rock falls; blocks more than 5 m in diameter were observed along the Padang-Bukittinggi Highway and Padang-Bungus [7].

Figure 7 Roadway damage due to slope failures in Padang Alai (on the southern margins of Maninjau caldera, ~30 NNE of Padang city), from [7].

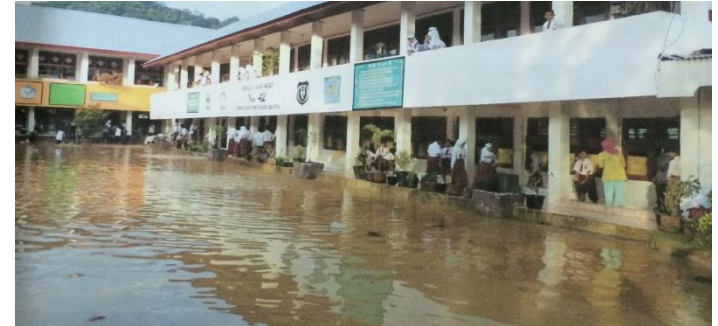
Site Location

- Inadequate consideration given to site selection
- Inadequate mitigation measures in place for hazardous sites
- Inadequate physical planning considerations
- Limited availability of land results in poor site selection

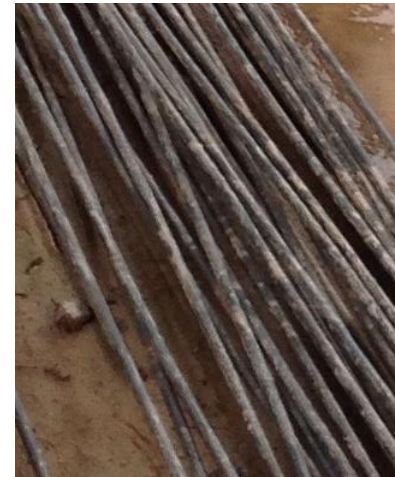
Buildings

- Lack of lintels
- Asbestos ceilings
- Smooth reinforcement is widespread
- Foundations not always adequate
- Roof covering connection to frame can be inadequate for high winds
- Light gauge steel roof frames becoming more popular but connections are not well understood – difficult to fix to, and doesn't support weight of a man for maintenance (but it is good for seismic and more available than timber)
