The World Bank
Global Program for Safer Schools
Tonga Mission Report

Issue | 16 December 2015

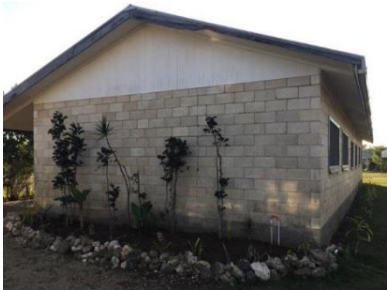
Building Typology	Photo	Advantages	Disadvantages
Unreinforced masonry Concrete block with no reinforcement

<ul style="list-style-type: none"> • Durable if material quality and workmanship is managed • Easy to build • Cheap • Use of local materials 	<ul style="list-style-type: none"> • Vulnerable in seismic regions
Reinforced masonry Concrete block with vertical and / horizontal reinforcement

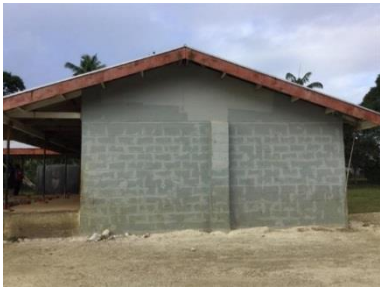
<ul style="list-style-type: none"> • Durable if material quality and workmanship is managed • Seismic resistance if constructed properly • Use of local materials 	<ul style="list-style-type: none"> • Slow to build • Requires skilled workers for correct assembly of reinforcement
Reinforced Concrete Frame with Masonry infill

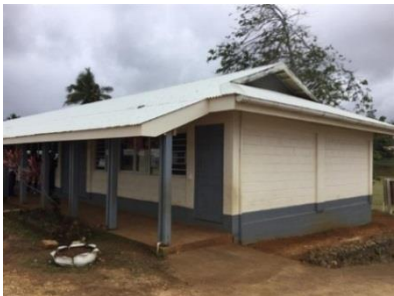
<ul style="list-style-type: none"> • Durable if material quality and workmanship is managed • Seismic resistance if constructed properly (infill walls must be tied together) • Use of local materials 	<ul style="list-style-type: none"> • Slow to build • Masonry façade may not be tied in • Complex seismic reinforcement detailing • Requires skilled workers for correct assembly of reinforcement • Requires an understanding of good seismic detailing

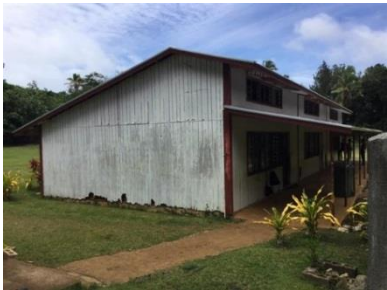
<p>Timber frame Lightweight timber frame with timber or plywood cladding</p>

<ul style="list-style-type: none"> • Easy to build • Quick to build • Timber frame is lightweight and ductile and thus is good for seismic 	<ul style="list-style-type: none"> • Untreated timber susceptible to insect attack and weather degradation • Materials are imported • Requires regular maintenance • Can be vulnerable in high winds if not appropriately detailed
<p>Mixed Masonry and Timber Low level masonry skirt wall with timber at higher level</p>

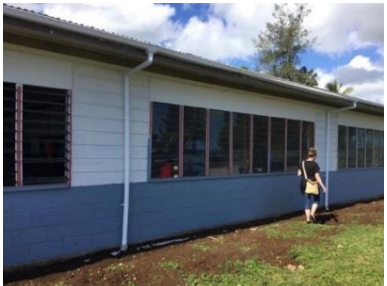
<ul style="list-style-type: none"> • Masonry wall at low level gives durability in splash zone • Lightweight upper level walls reduces seismic load 	<ul style="list-style-type: none"> • Two different trades are required • Detailing between materials can be complex • Untreated timber susceptible to insect attack and weather degradation
