The World Bank  
**Global Program for Safer Schools**  
Vanuatu Mission Report

Issue | 20 December 2015

Job number 238204-00

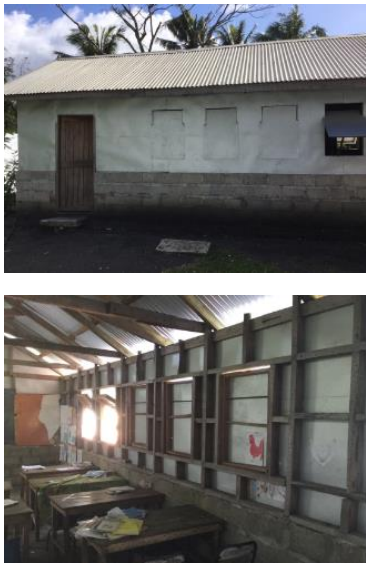
| School Building 'Type' | Typical Construction |
|--|--|
| <p><b><u>Type 1</u></b></p> <p><b>Community built</b> school buildings were typically 'semi-permanent', built with timber wall frames, often incorporating low level 'skirt' walls made of concrete block. These typically showed limited understanding of good construction practice which is likely to indicate that they were built without experienced trades or qualified supervisors.</p> | <p>The top image shows the exterior of a Type 1 school building, a single-story structure with a corrugated metal roof and a light-colored wall with a dark base. The bottom image shows the interior, featuring a long, narrow room with wooden desks and benches, and a wall with large windows and a wooden frame.</p> |

During the survey, Type 1 buildings were found to be significantly more vulnerable to cyclonic winds, and many were damaged beyond repair during TCP. Where failure of Type 2 structures was observed, it was predominantly due to a lack of building maintenance. Several interviewees reported a 'fatigue' within the school community, frustrated at the repetitive reconstruction which is required for semi-permanent structures. A detailed comparison of the key differences in the structural elements of the two construction types is tabled in Appendix F1.

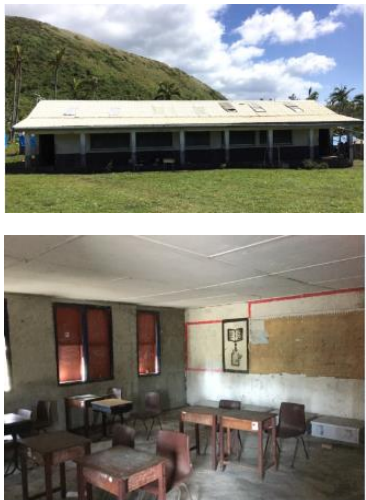
| School Building 'Type' | Typical Construction |
|--|--|
| <p><b><u>Type 2</u></b></p> <p><b>Donor built or colonial era</b> school buildings were typically 'permanent', built of reinforced concrete frame with infill concrete block masonry and generally followed a generic rectangular two classroom design. They typically showed a better understanding of good construction practice which is likely to indicate that they were built with experienced trades and/or with qualified supervision. The extent of involvement of the local school community in building Type 2 structures was not known at all schools, but it is likely that they contributed during the construction process.</p> | <p>The top image shows the exterior of a Type 2 school building, a single-story structure with a flat roof and a light-colored wall, situated on a grassy area. The bottom image shows the interior, featuring a room with wooden desks and chairs, a whiteboard, and a window with a wooden frame.</p> |

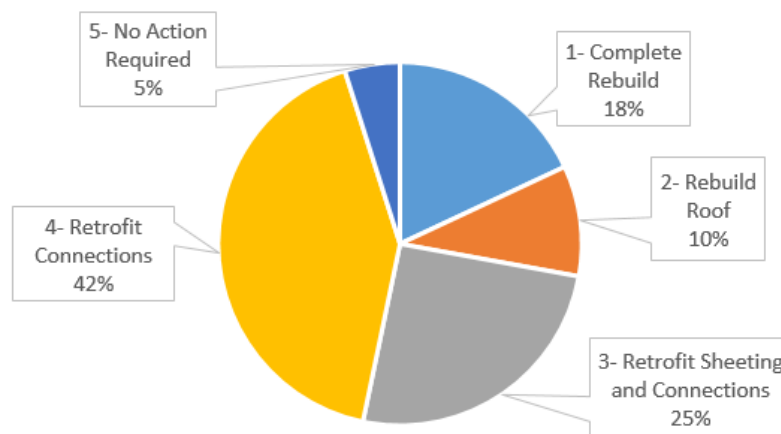
Figure 4: Remedial action required by building category for buildings surveyed

Rapid visual assessments carried out at 23 schools examined each classroom for structural vulnerabilities and categorised each building based on its condition. Classrooms were assigned to one of the five categories shown in Table 4 below. The remedial action that is required for each category is also shown based on the buildings potential to be retrofitted or repaired. Figure 4 shows the percentage of buildings from the whole sample which fall into each category.

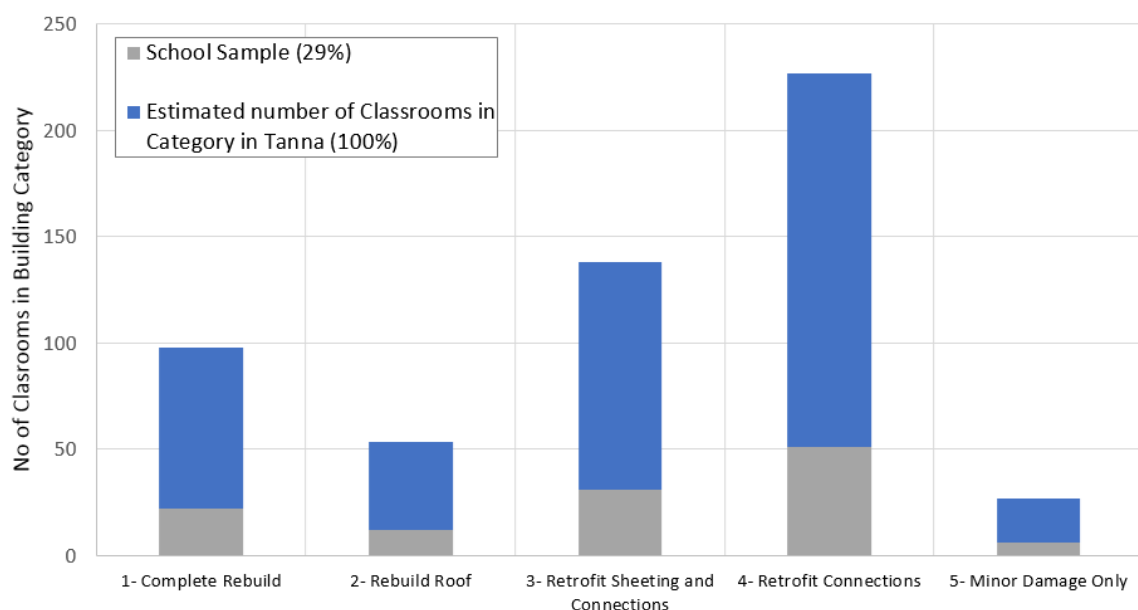
Figure 5: Estimate of classrooms to be reconstructed or retrofitted on Tanna

Taking a survey sample size of 29% and extrapolating to the full sample of schools on the island, an indicative number of classrooms to be reconstructed or retrofitted on Tanna can be determined as shown in Figure 5 below<sup>3</sup>.
