Global Facility for Disaster Risk
Reduction
Global Program for Safer Schools
Mongolia Mission Report

Issue | February 6, 2015

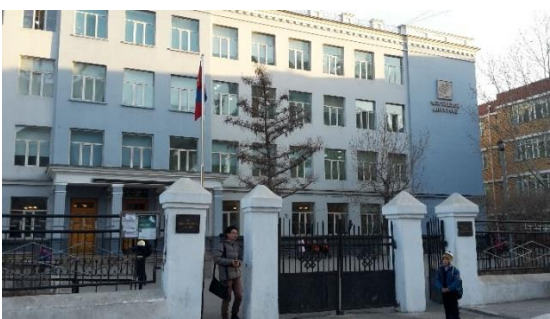
E1.1 Pre 1950 Un-reinforced Masonry

Location	Sukhbaatar District	
Year	1940	
Funding	Soviet/ Mongolian State	
Building design origin	Soviet Design	
Stories	4 + basement	
Construction Type	Loadbearing unreinforced masonry	
Floor type	Timber	
Survey?	RVA

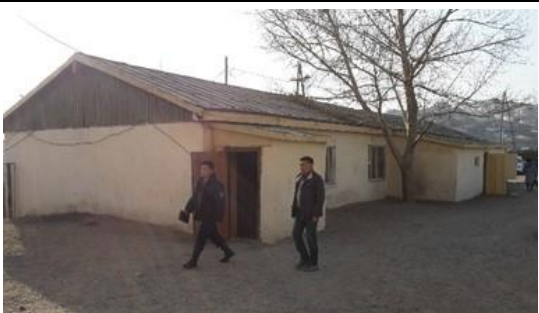
E1.2 Pre 1950 Timber

Location	Chingeltai District	
Year	Unknown	
Funding	Soviet/ Mongolian State	
Building design origin	Unknown	
Stories	1	
Construction Type	Timber	
Floor type	Timber	
Survey?	RVA

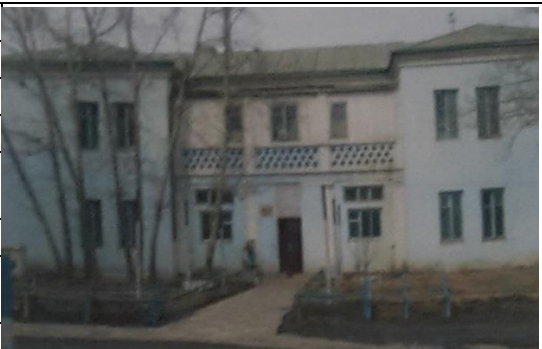
E1.3 Pre 1975 Soviet Model Unreinforced Masonry

Location	Songinokhairkhan	
Year	1958	
Funding	Soviet/ Mongolian State	
Building design origin	Soviet Model Kindergarten - 1	
Stories	2	
Construction Type	Loadbearing unreinforced masonry	
Floor type	Unknown	
Survey?	Demolished

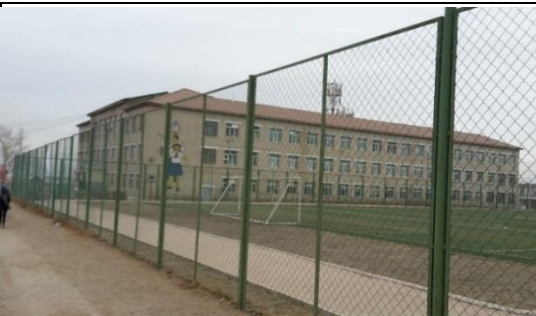
Khanuul District	
Year	1969	
Funding	Soviet/ Mongolian State	
Building design origin	Soviet Model School - 1	
Stories	3	
Construction Type	Loadbearing unreinforced masonry	
Floor type	Precast RC hollowcore plank	
Survey?	RVA

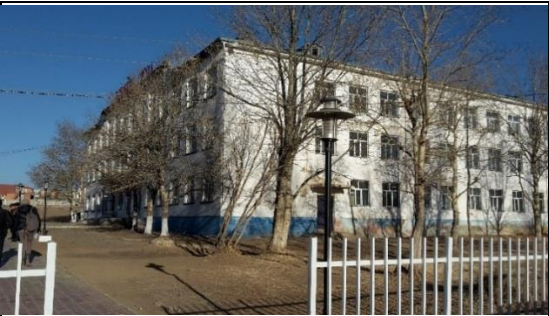
Location	Nalaikh District	
Year	1973	
Funding	Soviet/ Mongolian State	
Building design origin	Soviet Model School - 1	
Stories	3	
Construction Type	Loadbearing unreinforced masonry	
Floor type	Precast RC hollowcore plank	
Survey?	RVA
