VULNERADILII I KE	DUCTION SOLUTION		Author: Sheet:	UCL
	DAD BEARING MASONRY BUILDINGS	5	Sheet.	1012
STRENGTHENING INTERVENTION:	POLYPROPYL	LENE (PP)	) BAND ME	SH
APPLICABLE BUILDING TYPES:				
	Taxono	my Parameter	s	
Main Structural System:	A X UCM-URM X	CM	RM	SFM X
Height Range:	Low (LR) X	M	edium (MR) X	High (HR) X
Seismic Design Level:	Poor (PD) X Low (LD) X	Me	edium (MD)	High (HD)
Structural Health Condition			Poor (PC) X	Good (GC)
EXISTING STRUCTURAL DEFICIENCIES:

# **VULNERABILITY REDUCTION SOLUTIONS**

LOAD BEARING MASONRY BUILDINGS

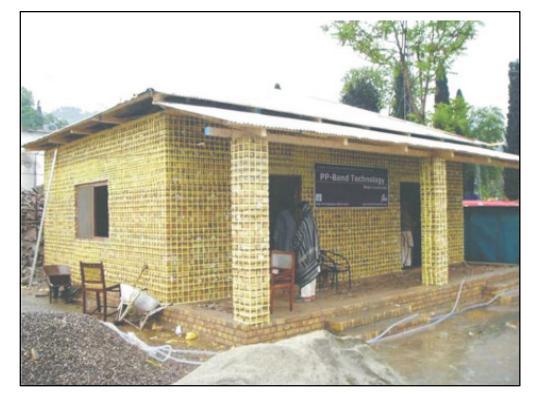
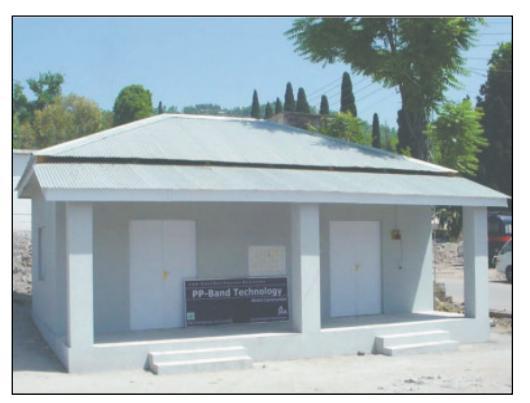
Retrofitted house in Pakistan using the PP Band meshing: Application of PP band (left) and building after plastering (right) (Reproduced from Macabuag et al. 2010)

This intervention requires skilled masons at it involves plaster removal, drilling through the walls etc. The PP straps are commonly used for packaging, hence it is a low cost technique. This is applicable mainly to low strength masonry buildings i.e. adobe (A), brick in mud mortar (UCM-URM4) stone in mud mortar (UCM-URM2, UCM-URM3) types of school buildings.

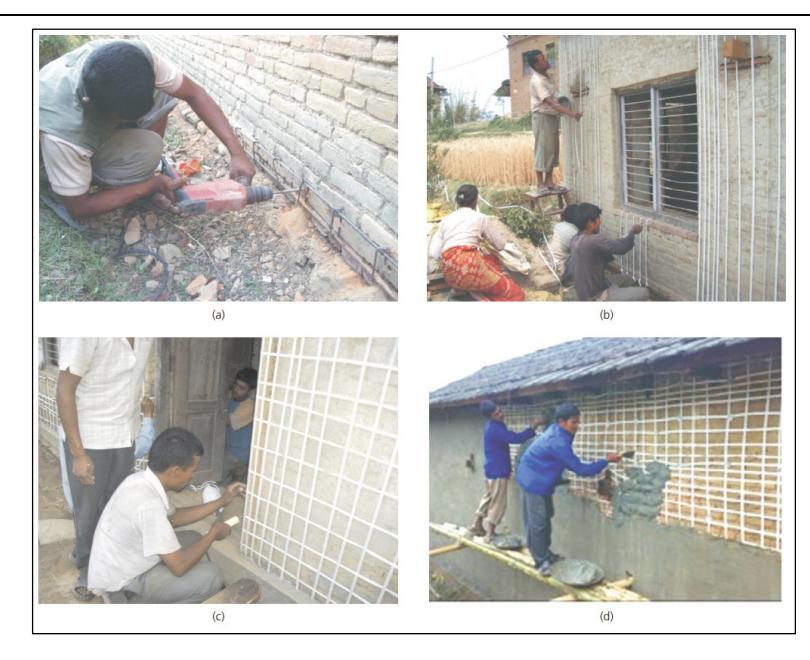
Strengthening of an adobe building using PP Band meshing (Photo from Nepal, Photo credit: NSET. Reproduced from Macabuag et al. 2010).
