Understanding Existing School Infrastructure – a New Zealand Experience

Overview

Country: New Zealand

Hazards: Earthquakes

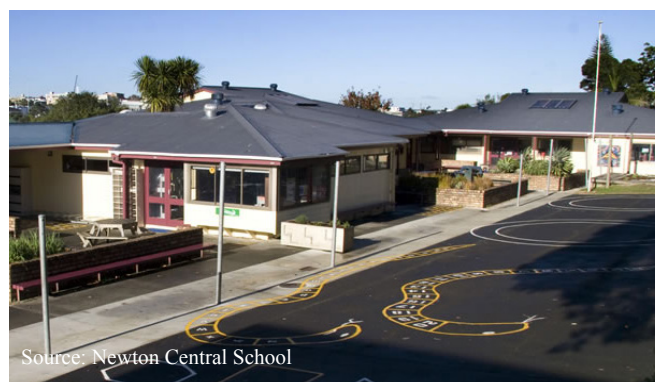
Source: Newton Central School

90% of schools in New Zealand are timber frame low rise construction typology which can perform well in an earthquake due to the lightweight and flexible nature of the structure.

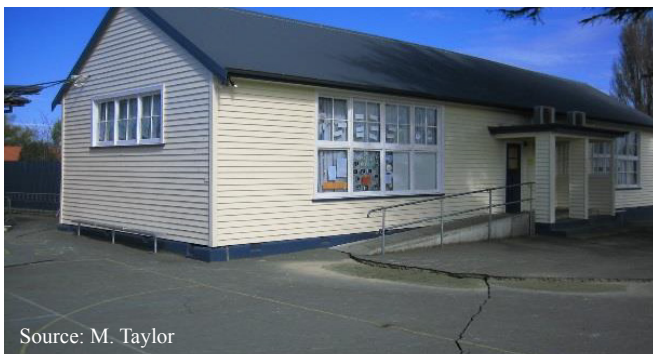
Source: M. Taylor

Lightweight timber clad low rise school buildings can often suffer little or no damage during significant earthquake events
